THE STREAMBANK EROSION CONTROL  
EVALUATION AND DEMONSTRATION ACT OF 1974  
SECTION 32, PUBLIC LAW 93-251

Appendix G - Demonstration Projects on Other Streams, Nationwide

# FINAL REPORT TO CONGRESS

## APPENDIX G DEMONSTRATION PROJECTS ON OTHER STREAMS, NATIONWIDE

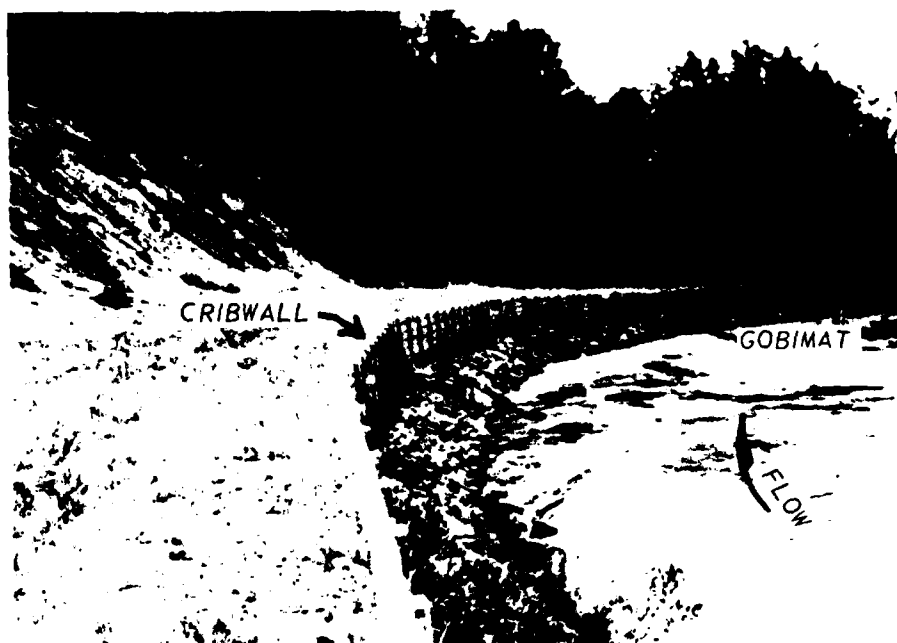
PHOTOS 1 AND 2

PHOTO NO. 2. 9 Nov. 78. Under construction; downstream portion of project.

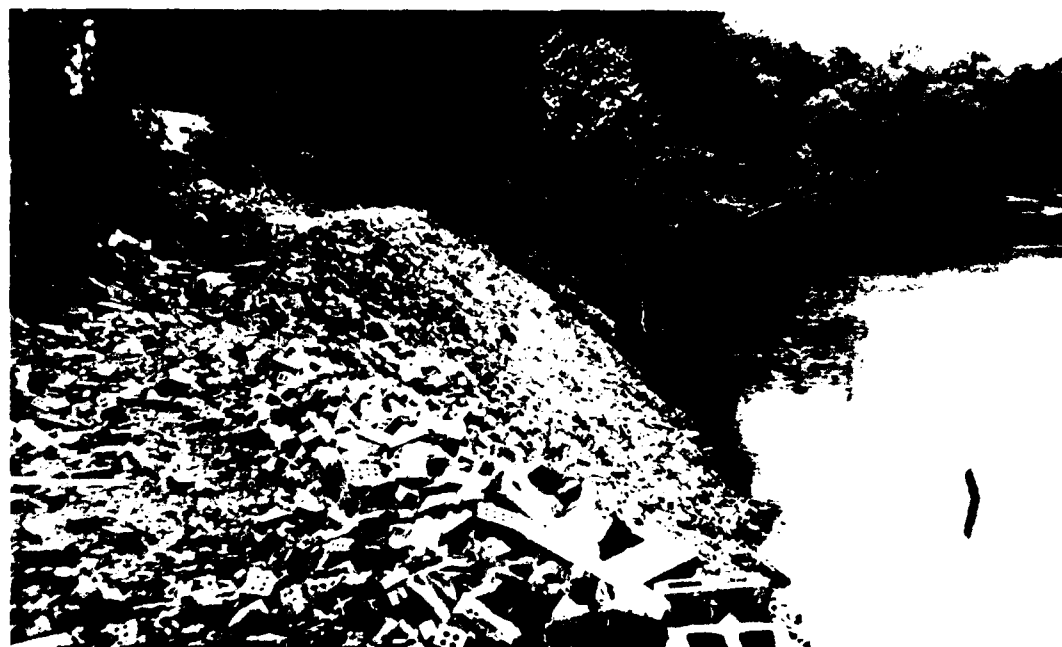
AFTER FLOOD OF MAY 1981. NOTE UPSTREAM VIEW, TOP OF RUBBLE 190 FEET N.G.V.D., 18 FEET ABOVE WATER SURFACE.

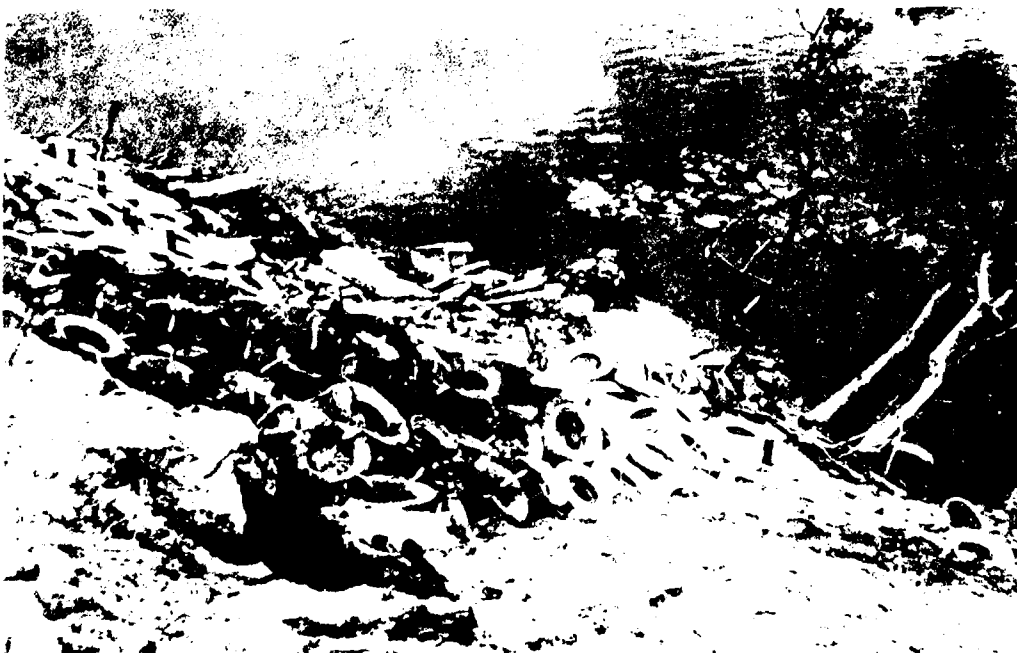
AFTER FLOOD OF MAY 1981. NOTE FLOW TO THE RIGHT, TOP OF STRUCTURE 190 FEET N.G.V.D., 18 FEET ABOVE WATER SURFACE.

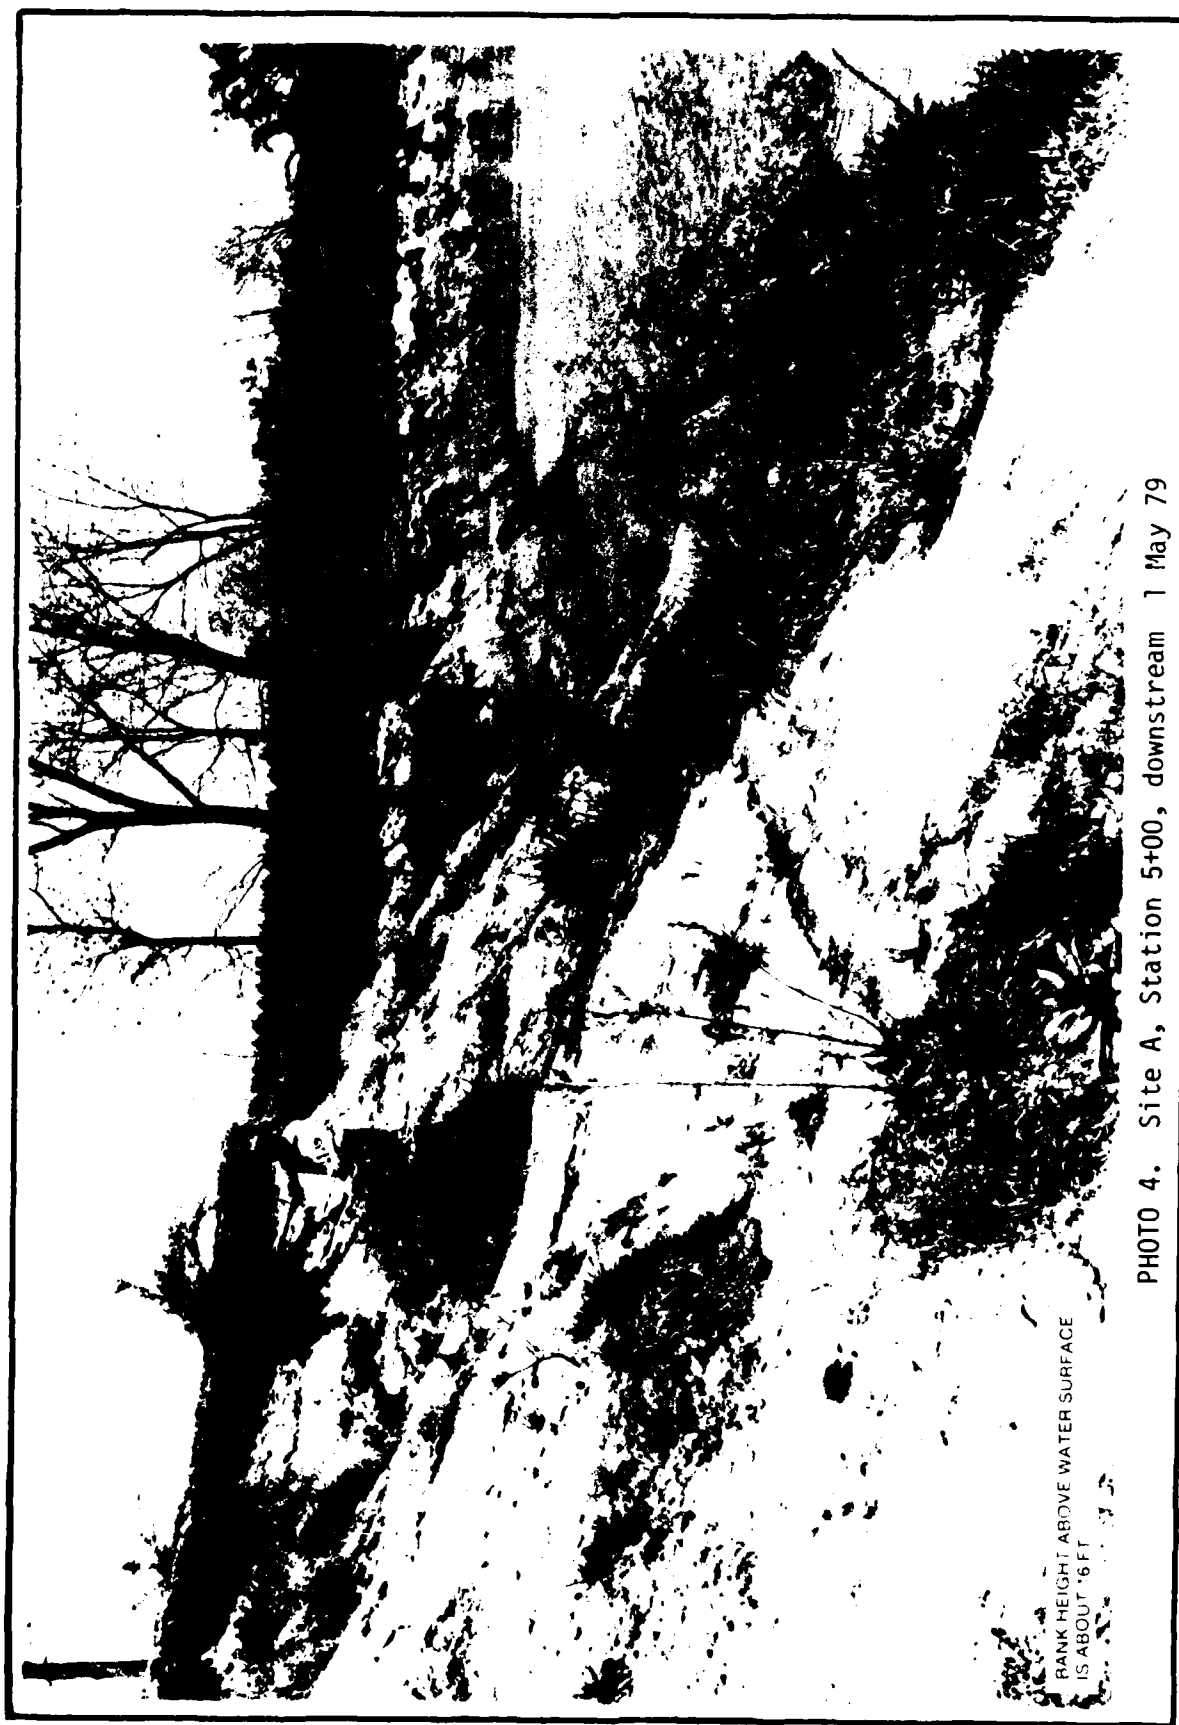
PHOTO 4

BANK HEIGHT ABOVE WATER SURFACE  
IS ABOUT 16 FT

PHOTO 4. Site A, Station 5+00, downstream 1 May 79

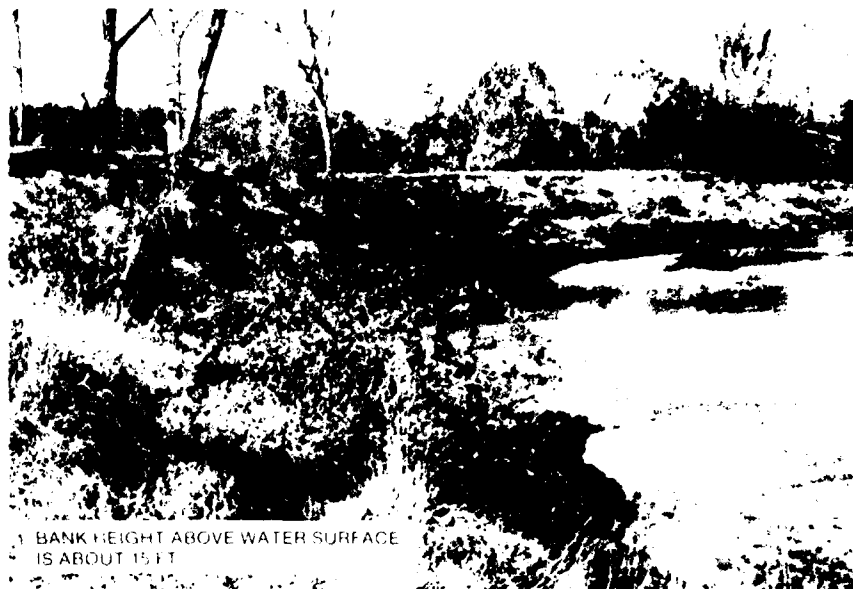
BANK HEIGHT ABOVE WATER SURFACE  
IS ABOUT 15 FT

PHOTO 5. Site A, Station 5+00, downstream 24 Oct 79

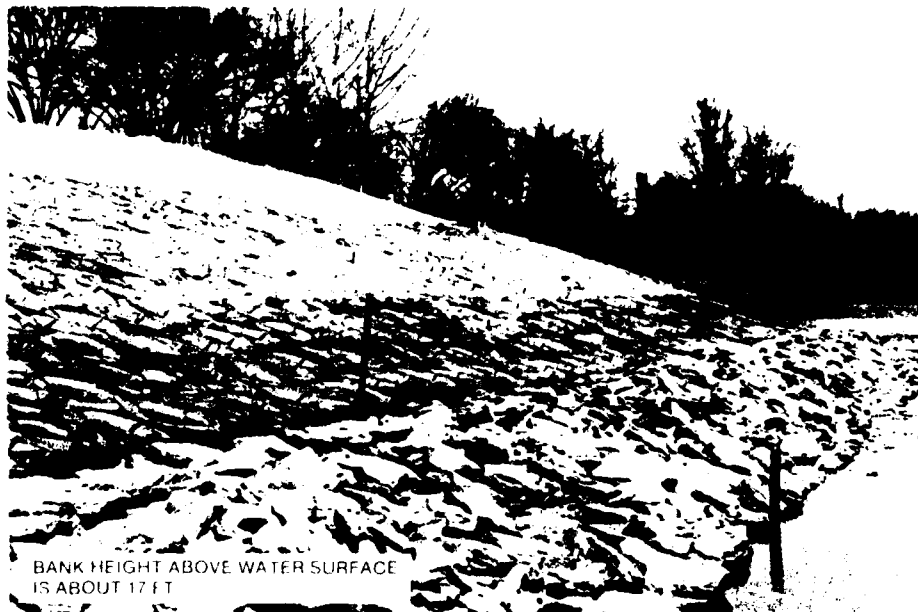
PHOTO 18. Site A, about Station 9+00. View of rubber tire mattress - rock toe immediately after construction. 21 Mar 81

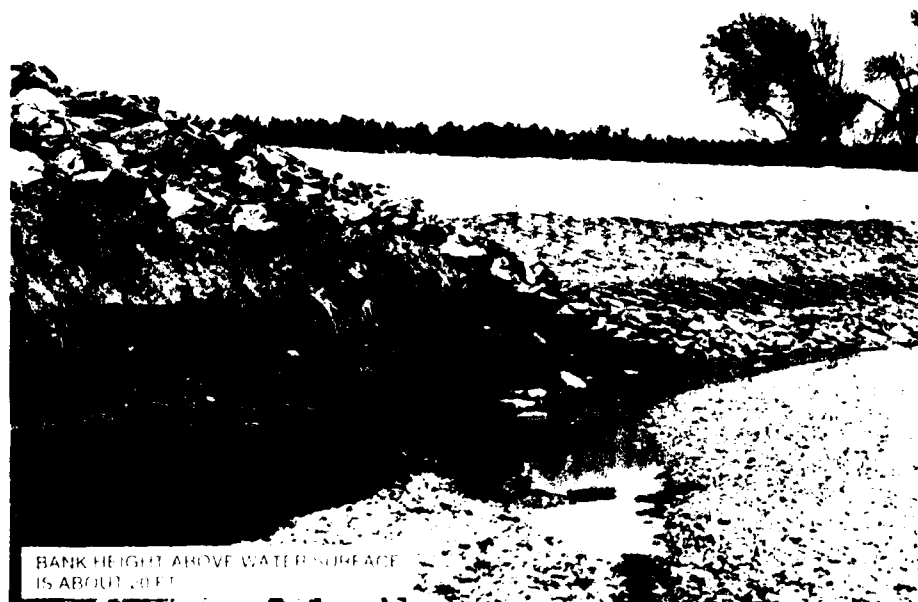
PHOTO 19. Site A, Station 7+00, downstream. Transition from stone rubble to tire mattress - rock toe immediately after construction. 21 Mar 81

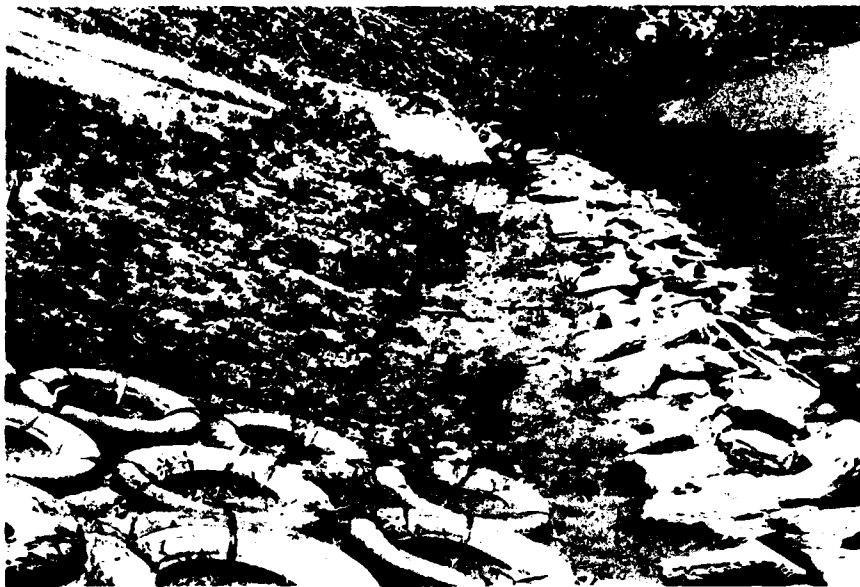
PHOTO 24. Site A, downstream view, Station 12+50 to 13+00 showing lower 50 feet of project that received only rock toe and grass cover (no tires). 21 May 81

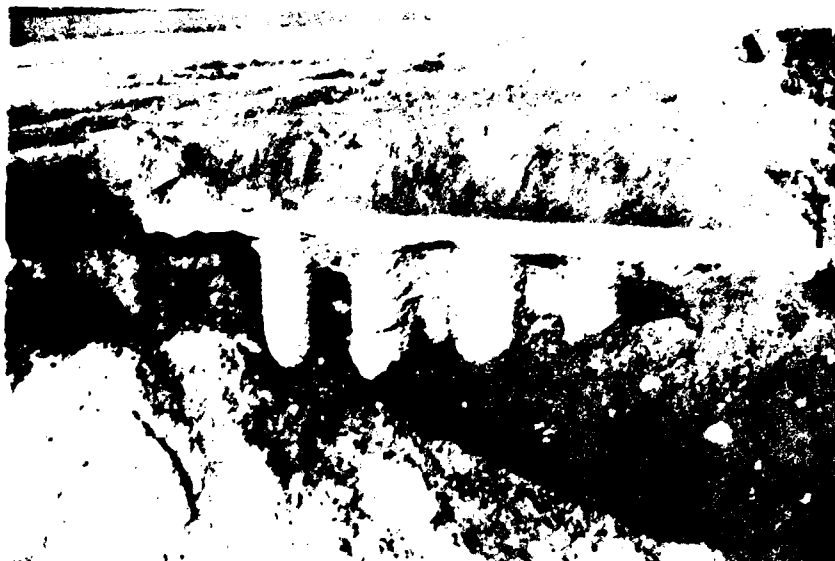
12. Evaluation of Protection Performance. - Preliminary observation of the performance of the concrete pile groins has been possible since the groins have sustained one winter's flow. Seventeen concrete pile groins were constructed as shown on Plate 6. The groins were inspected in April 1981. Most of the groins were found to be completely embedded in the natural river bank with no portion of the structure being visible. However piles 5, 11, 14, 15 and 17 had been partially exposed due to the erosive action of the river and bank failure caused by flow over the berm. Piles 5, 11 and 17 appeared to have been exposed by river currents, whereas piles 14 and 15 appeared to have been exposed by flows over the berm returning to the river. During construction of the vegetation cover section, the area immediately behind the groins was regraded so return flows on the berm would be diverted away from the groins.

Station 18+20 - Looking at downstream side of groin  
Number 14 - Erosion to a depth of 10 feet (April 1981)

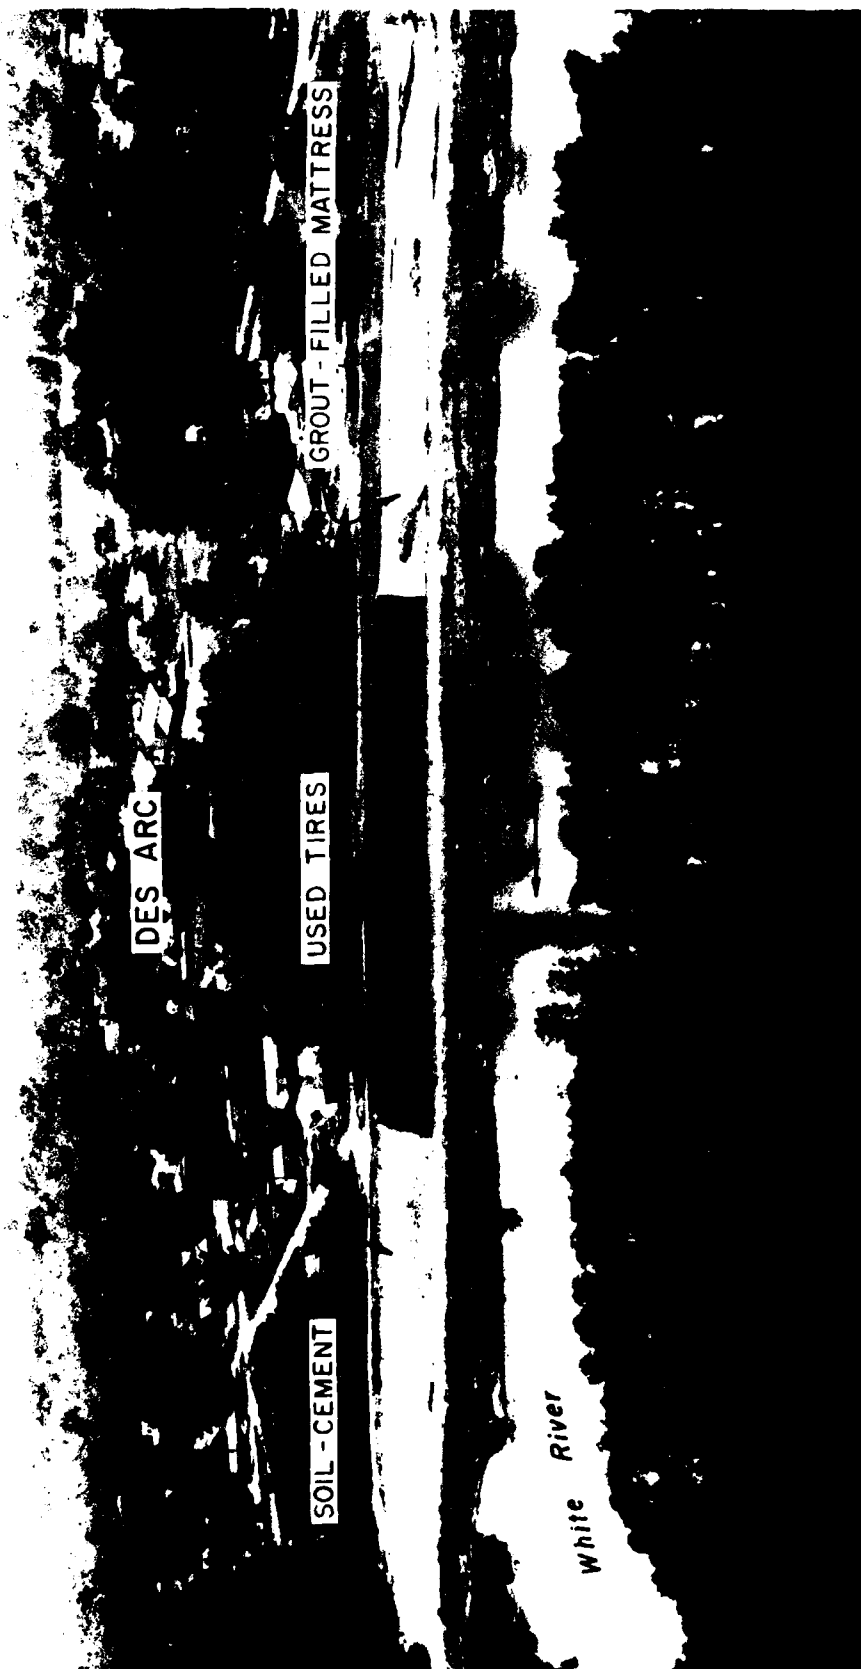
PHOTO 14

VIEW OF COMPLETED PROJECT SHOWING  
3 TYPES OF BANK PROTECTION
